CHURCH OF THE " HOLY SEPULCHRE JERUSALEM

STRUCTURAL SURVEY
FINAL REPORT

BY
WILLIAM HARVEY

1935

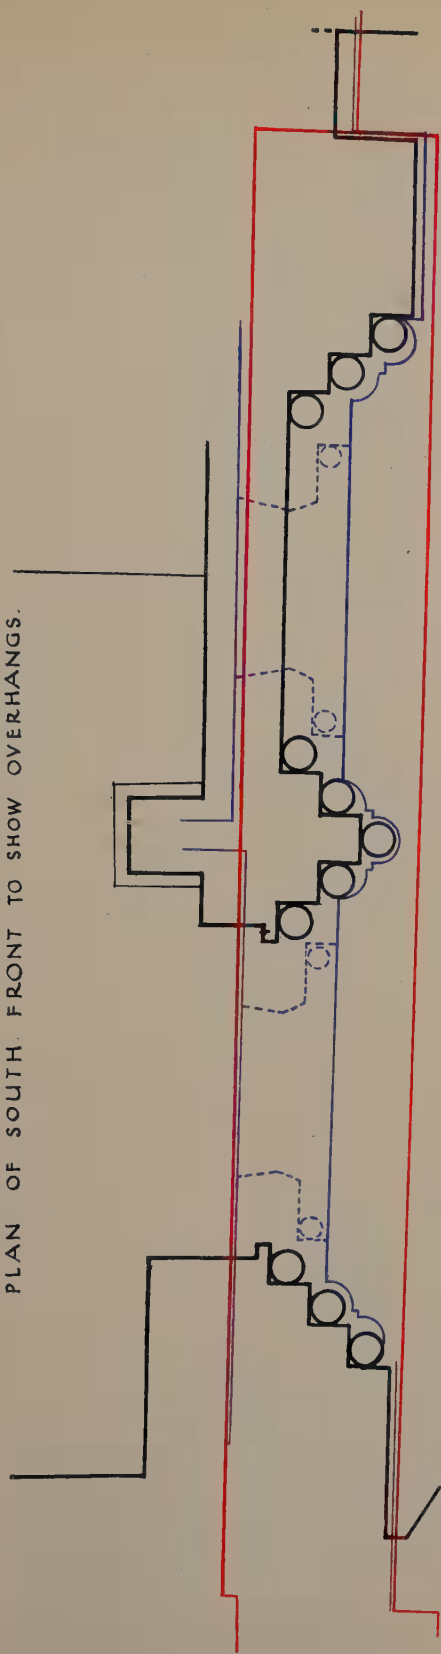
CHURCH OF THE HOLY SEPULCHRE
 PLAN OF SOUTH FRONT TO SHOW OVERHANGS.

PLAN OF LOWER STORY SHOWN BLACK
 " " UPPER " " BLUE
 " " WALL TOP " " RED

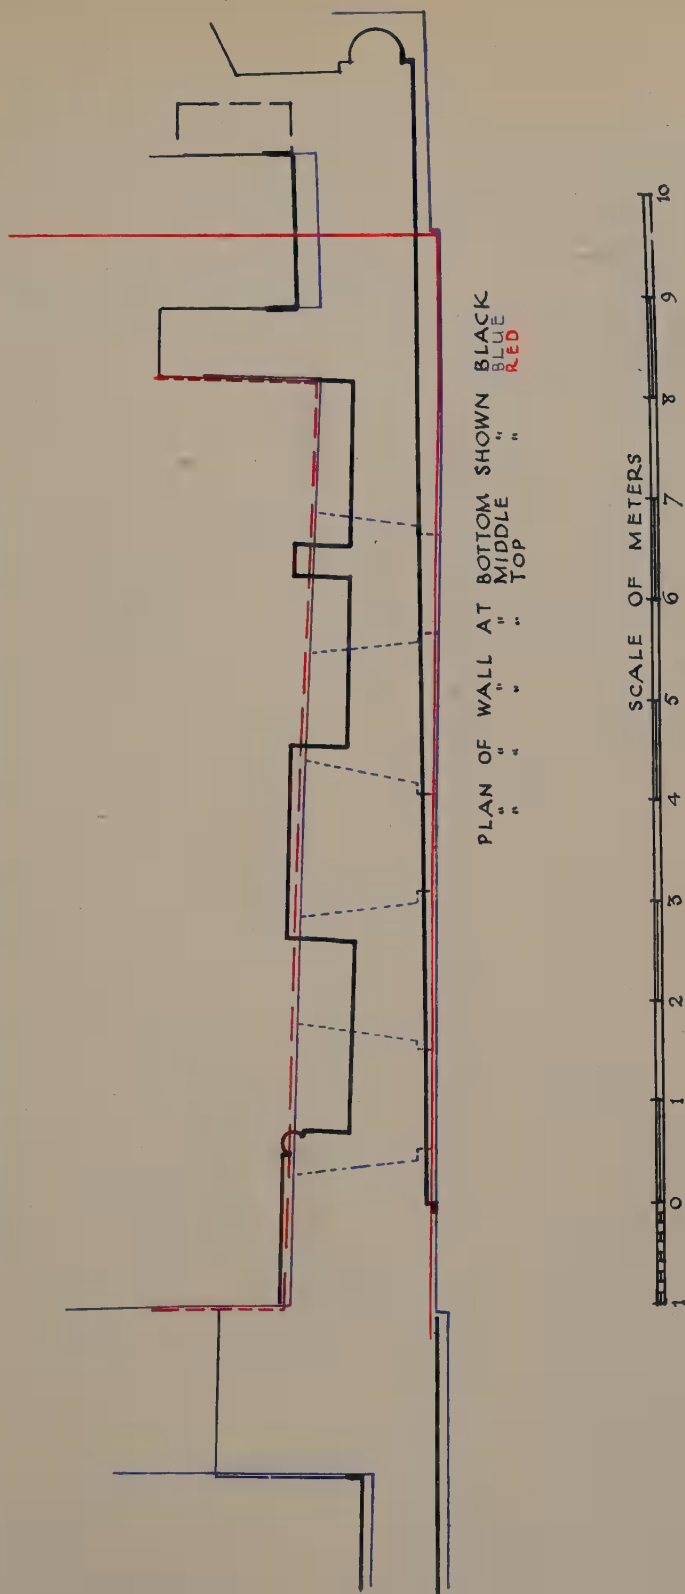
FIG. V

by $22\frac{1}{2}$ centimetres, and the crown of the vault is cracked throughout its length (see Figs. 63, V).

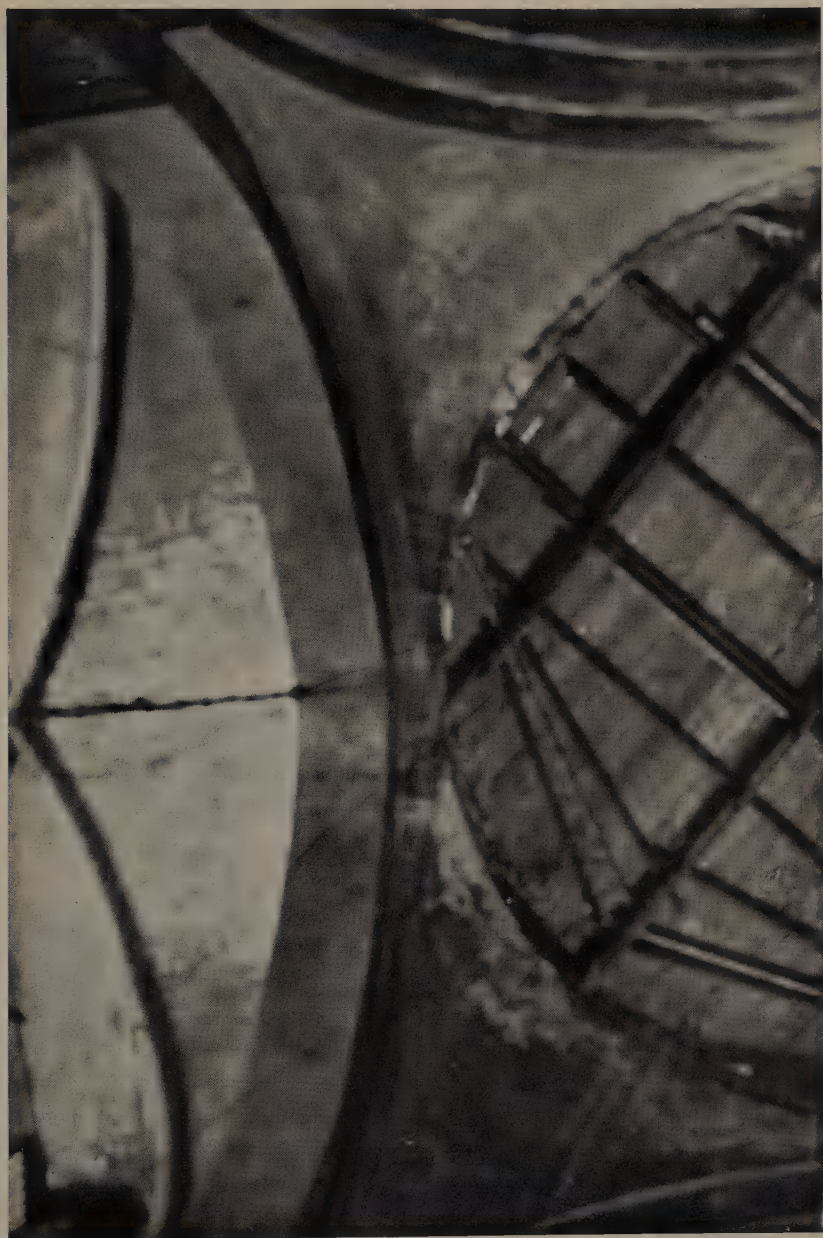
FIG. 1. EASTERN PENDENTIVES FROM BENEATH

The pendentives (see Figs. 1, 2, II, 24) receive the weight of the dome and transmit it to the four main piers below, but there is also considerable outward thrust, as the pendentives are not vertical, but inclined inwards to the bottom of the drum above. They were completely plastered over after the fire of 1808, and do not themselves show signs of great movement, except in the North-west pendentive, which is badly cracked. The piers below have decided leans outwards in the upper portions, and from this inclination the further parts of the building have received the damaging thrusts (see Additional Notes, p. 14).

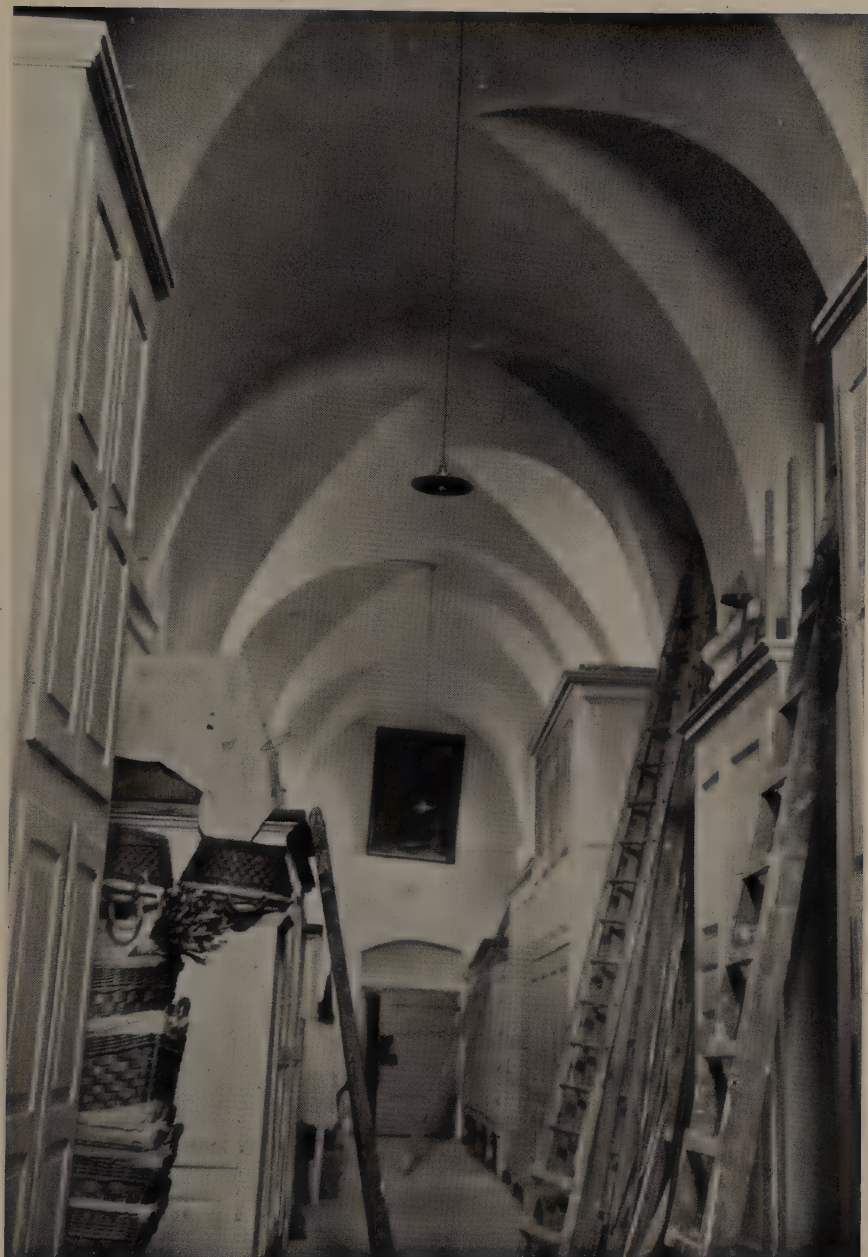
FIG. 11. VAULT OF NORTH TRANSEPT

The high vault itself (see Fig. 11) has also been plastered, but some two years ago a large stone fell from one of the main ribs, and the upper walls, where accessible from outside, are in an extremely poor condition (see Figs 12, 13, 14), many joints being completely denuded of mortar, and much of the masonry cracked and suffering from erosion, and to some extent from the effects of the fire of 1808.

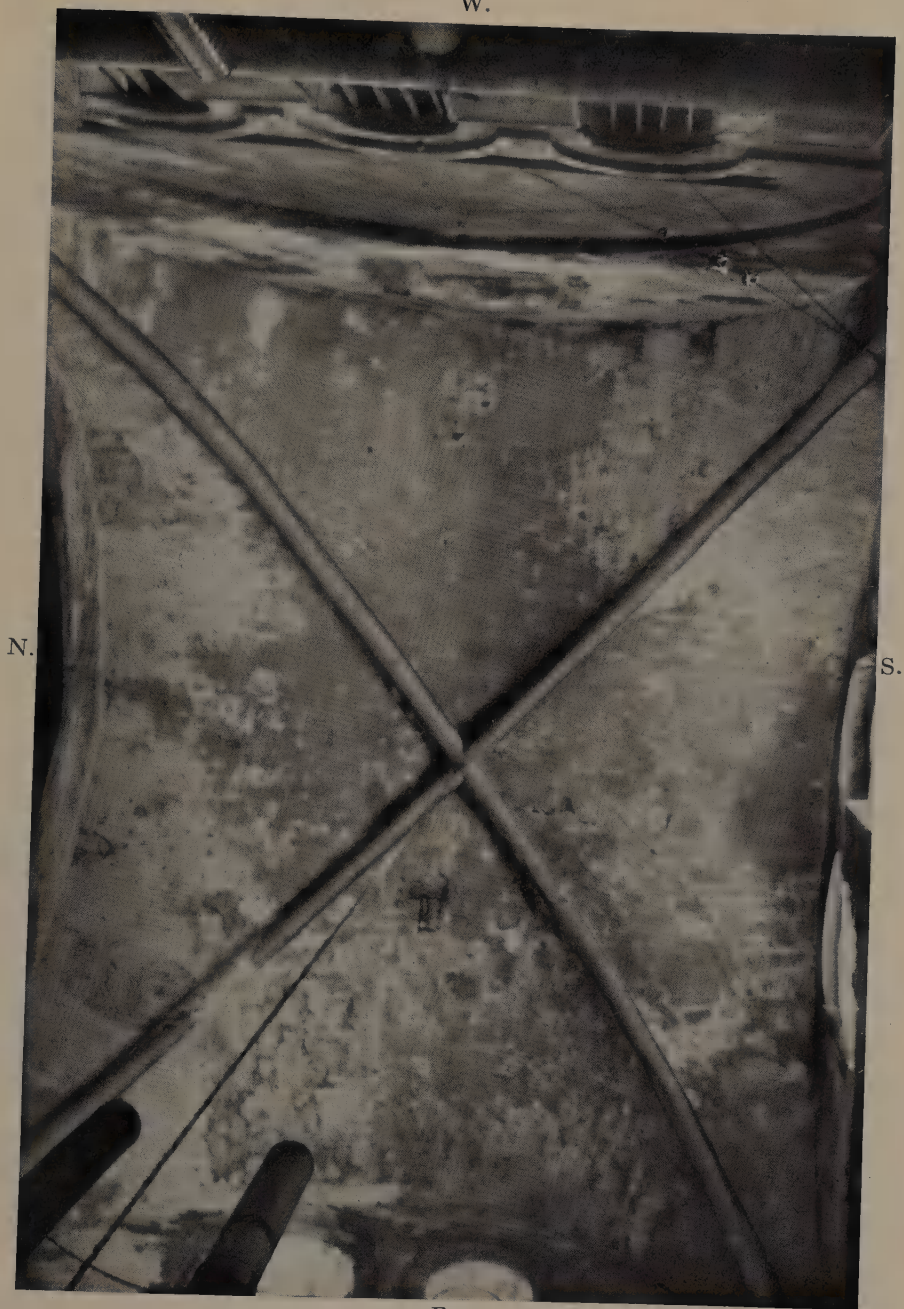
FIG. 21. SOUTH TRANSEPT FROM N.W.

The South Transept (see Figs. I, 1-II, 2), including the main front of the Church, contains much twelfth-century work; but the interior suffered greatly from the fire, and was partly rebuilt (see Figs. 21, 22, 23). The South wall shows very considerable calcining of the masonry, principally in the upper story, and a large proportion of the stonework is unfit to support the superincumbent weight and thrusts.

FIG. 22. SOUTH TRANSEPT E. WALL

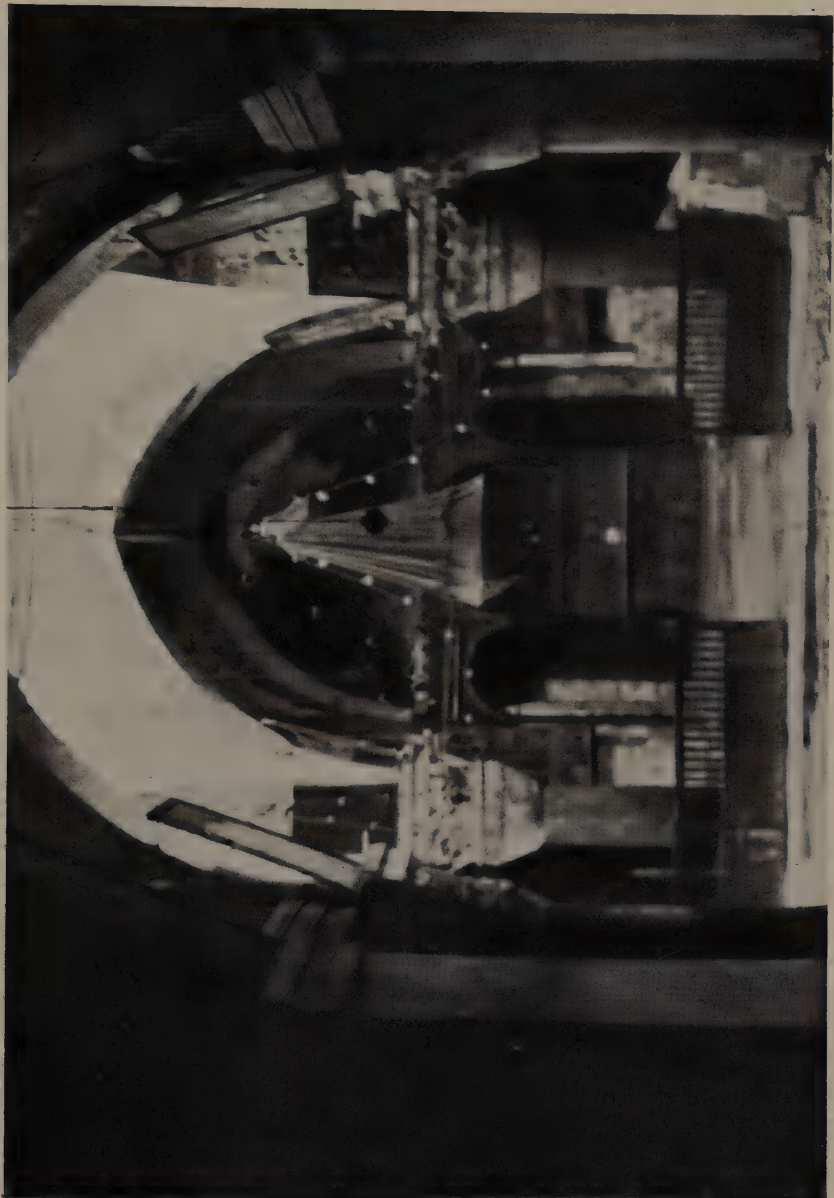
FIG. 44. ST. HELENA'S CHAPEL FROM W.

The Chapel of St. Helena (see Figs. 44, I, 28) lies below ground-level (see Fig. 45) and there is consequently but slight

FIG. 45. STAIRS TO ST. HELENA'S CHAPEL

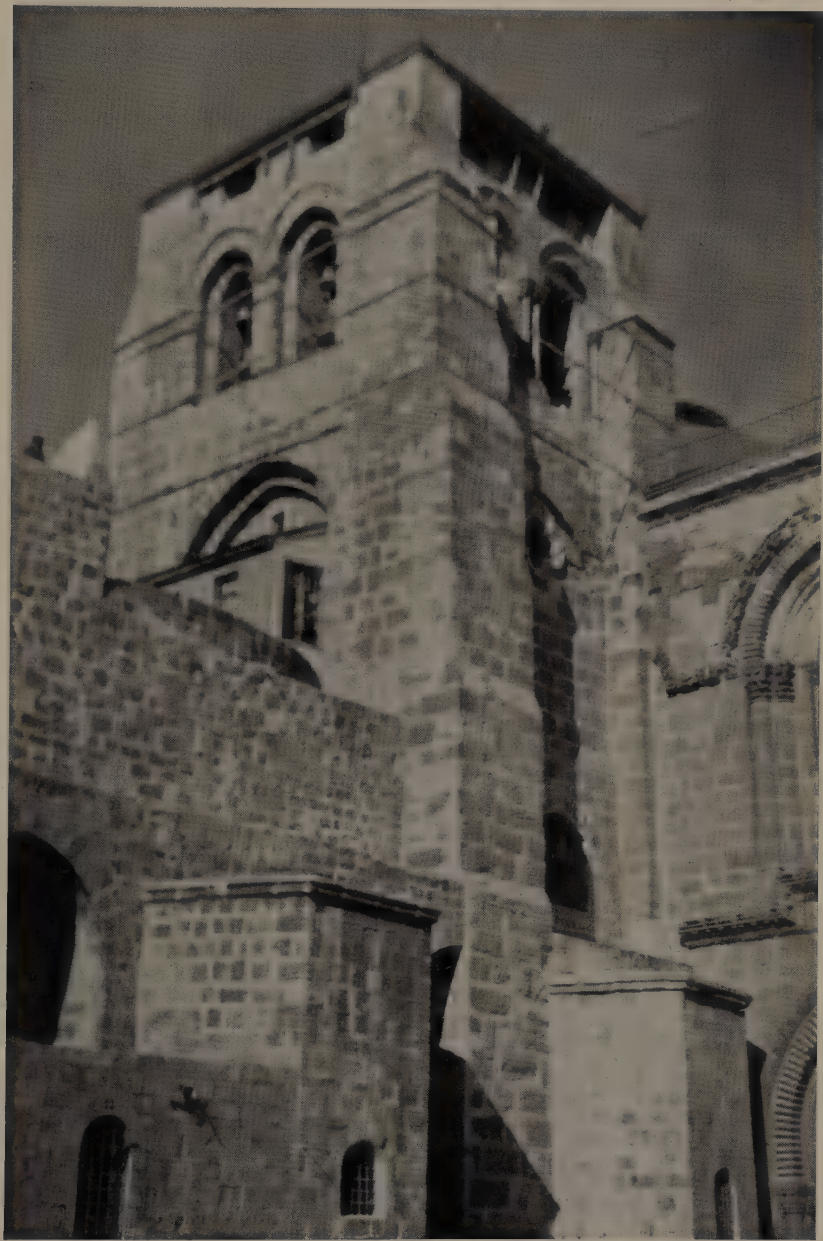
FIG. 65. FRACTURES DUE TO RUSTING IRON CRAMPS.
ROTUNDA PIERS

The piers of the main Rotunda (see Fig. I, 13) are now square (see Fig. 64), though they probably enclose as a core the earlier round columns of the building of Constantine Monomach (c. A.D. 1048). The present piers are clamped together with rusting iron (see Fig. 65), are very irregular in shape and size, and are not placed symmetrically beneath the circular drum built in 1867. They are therefore subject to eccentric loading, and all of them show cracks to a greater or less extent; some of these cracks are serious, though certainly due to earthquake shock as well as to thrusts (see Fig. 66).

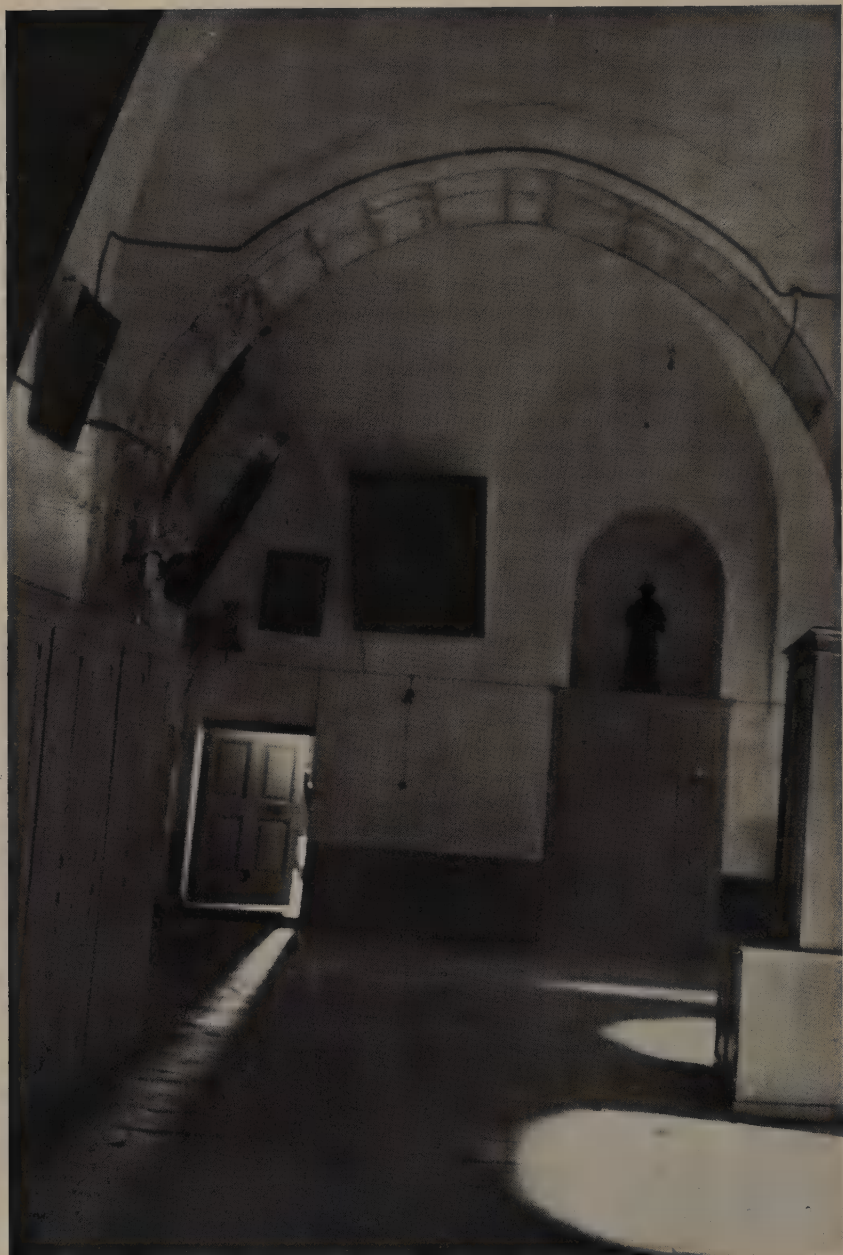
FIG. 67. FRANCISCAN UPPER GALLERY OF ROTUNDA

The galleries of the Rotunda (see Fig. 67) surround the main piers, and are enclosed by a circular wall, whose lower portions date from Constantine's original Anastasis (see Fig. 68). This circular wall leans outwards owing to the thrusts of the gallery vaults and the communicated thrusts of the cone which covered the central space prior to 1808.

FIG. 68. BYZANTINE OUTER WALL OF ROTUNDA IN UPPER GALLERY

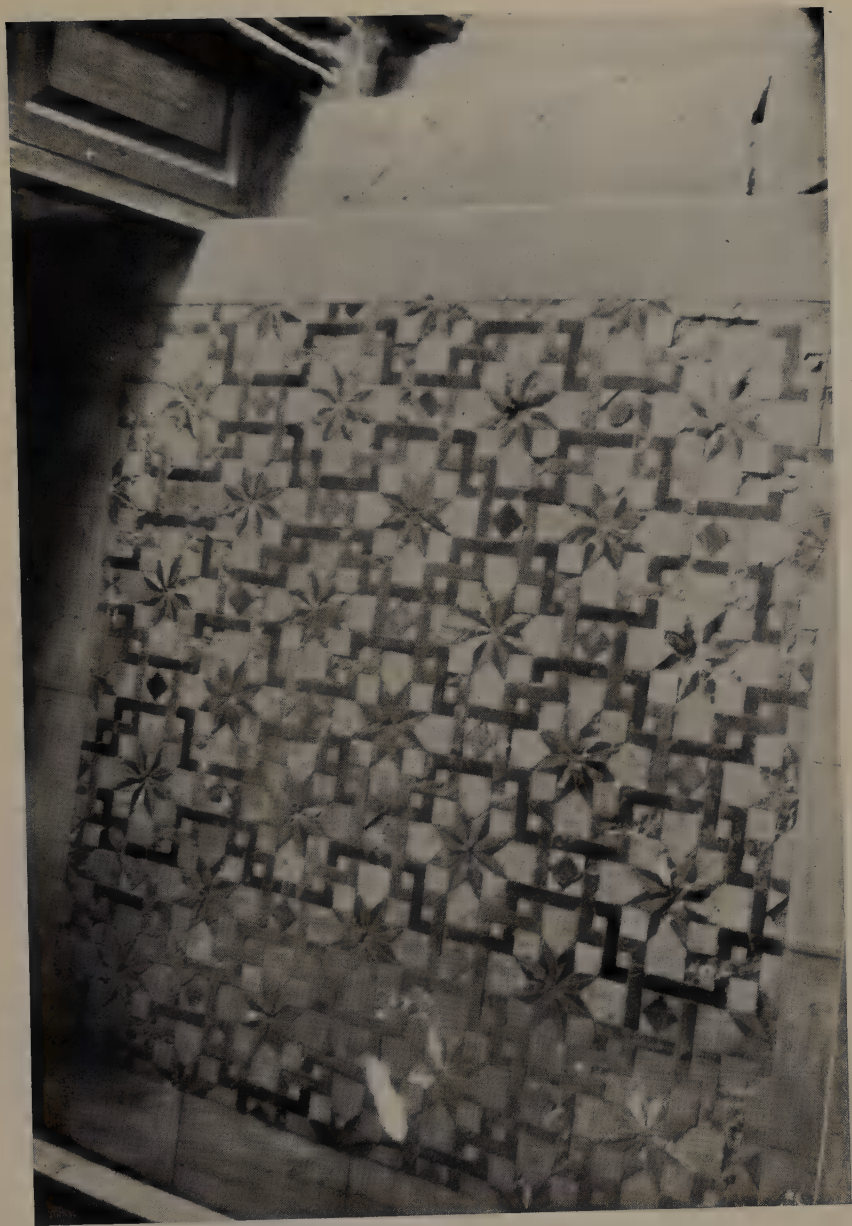
FIG. 81. PAVEMENT IN CHAPEL OF THE FRANKS

FIG. 82. PAVEMENT OF PARVIS FROM ABOVE

FIG. 83. STAIRS FROM GROTTA OF THE INVENTION

1. Chapel of the Apparition (see Fig. I, 14). The new marble slabs should be taken up, and the original mosaic reinserted. (The original is at present in the Latin gallery of the Rotunda.) (See Fig. 80.)
2. Chapel of the Franks (see Fig. I, 44) (Chapel of Our Lady of the Seven Sorrows). This original pavement requires very careful resetting, and the insertion of a few small fragments (see Fig. 81).
3. Latin Calvary Chapel (see Fig. I, 43). This pavement contains much original work, which should be reset.

The work should be done with special regard to possible remains of archaeological interest beneath (see Fig. 82).

(5) The stair from the Chapel of St. Helena to the Grotto of the Invention should have its present iron gratings removed; the original steps can then be reset, with insertions of new stone where necessary (see Figs. 83, I, 28, 29).

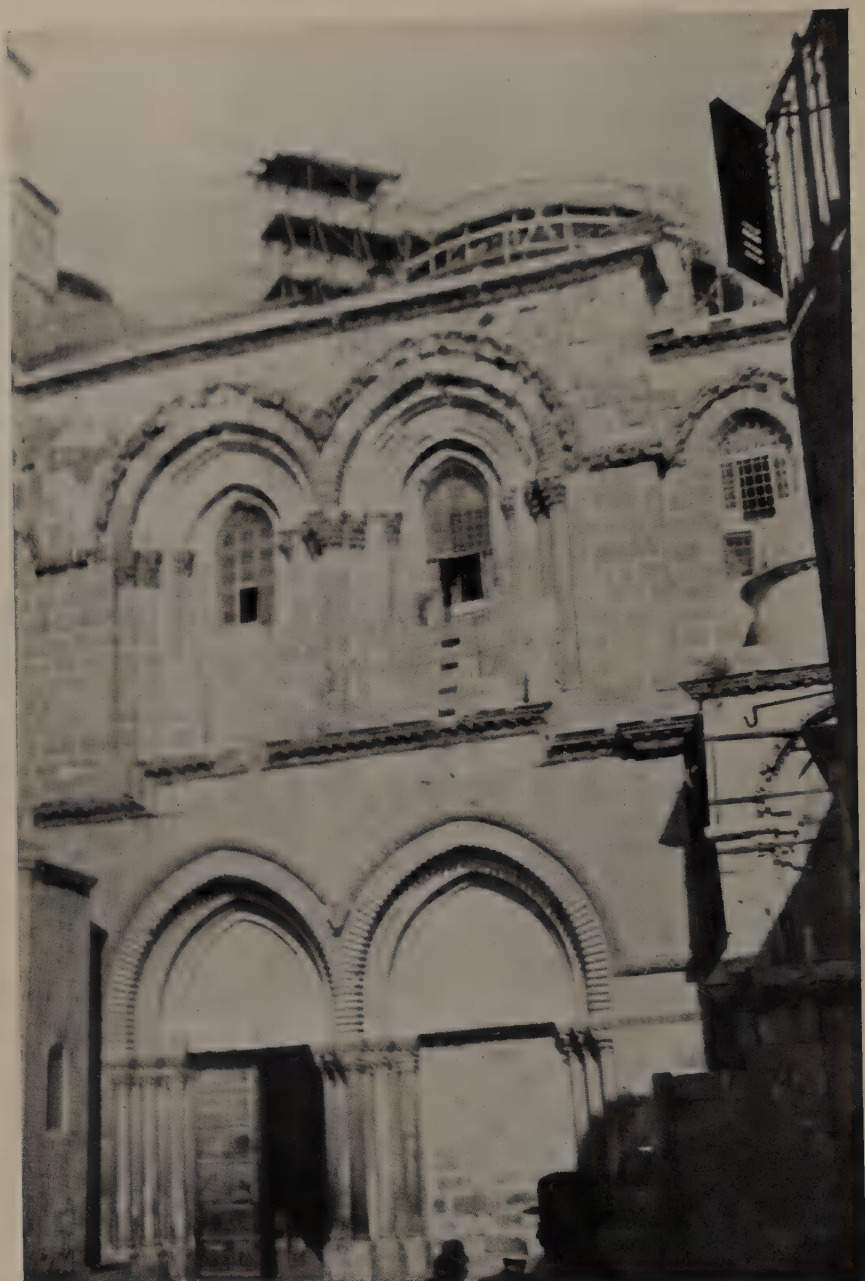
FIG. 84. MAIN FRONT

FIG. 85. CHAPEL OF THE FRANKS

(1) The reopening of the eastern main doorway of the Church (see Fig. 84) and the removal of the modern work behind it enclosing the present double stair to Calvary. This would also remove a small portion of the western end of the Greek room under the southern stair, and of the Chapel of Adam. The place of the removed lintel-carvings should be filled either with good casts, or with well-carved copies (see Frontispiece to Report).
